7453 South Norfolk Street
Aurora, Colorado 80016
Office Phone: 800-637-1322
Office Fax: 303-309-0097

Inspection Report for San Bernardino County

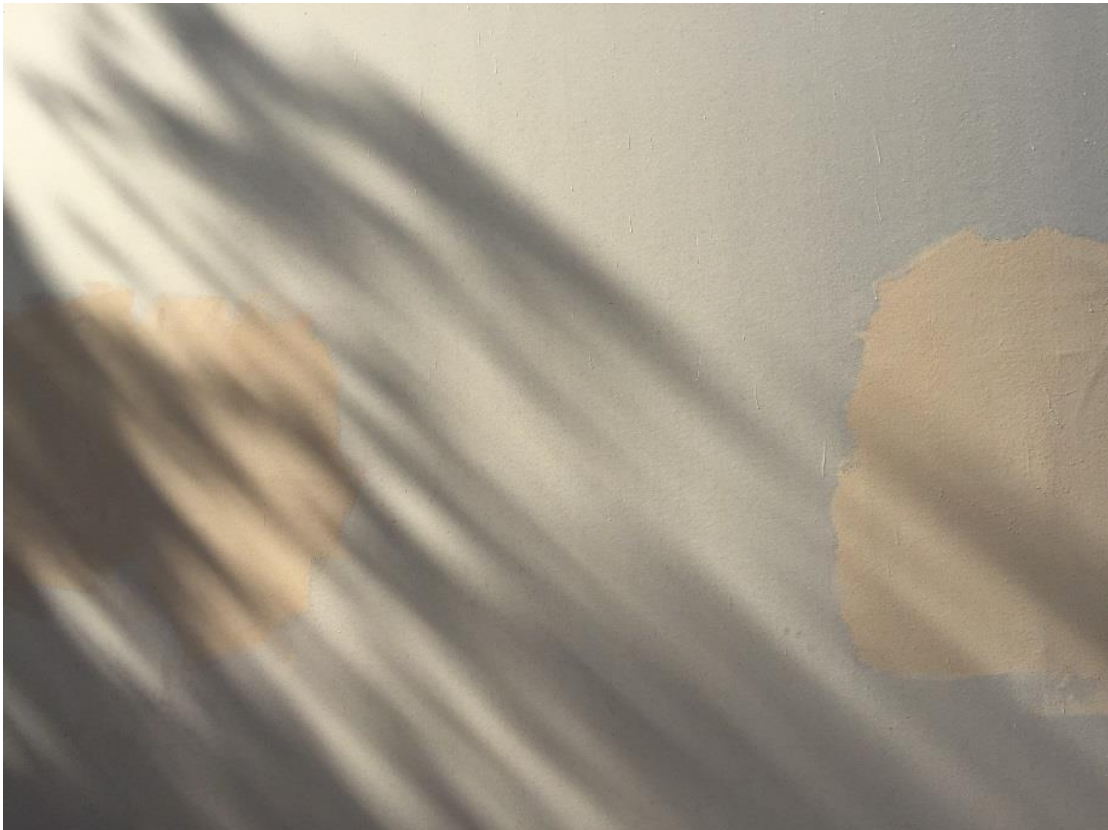
Summary: The wall panels have good coating conditions overall. Minor pinhole corrosion spots present.

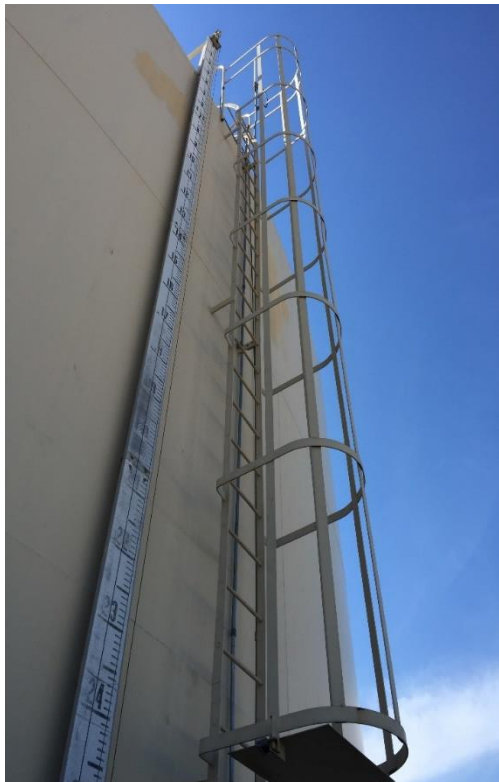
Summary: The ladder has good coating conditions overall. Minor uniform surface corrosion noted.

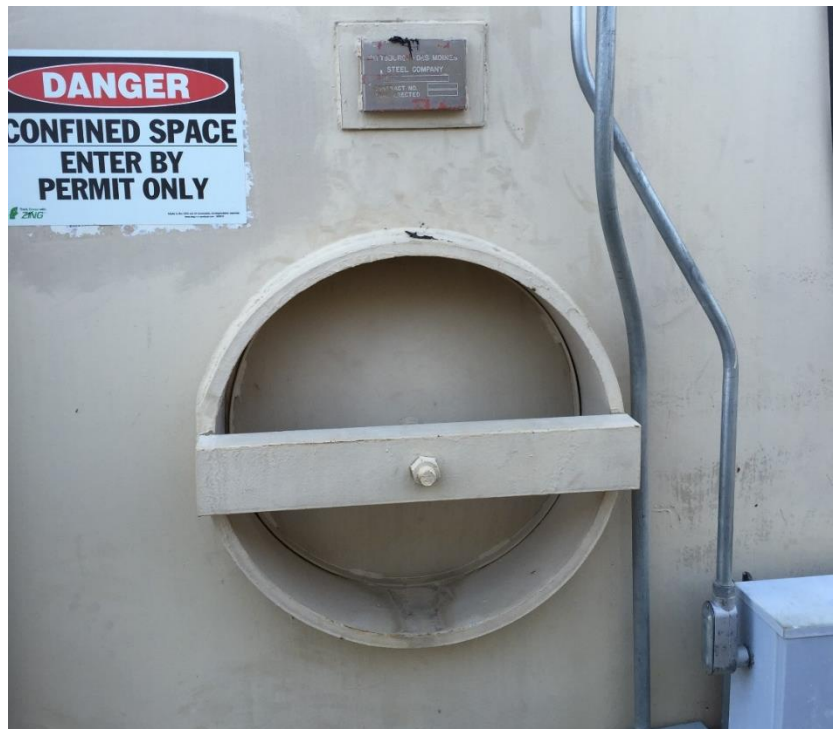
Summary: The manway has good coating conditions overall. Minor uniform surface corrosion is the only discrepancy found during the inspection.

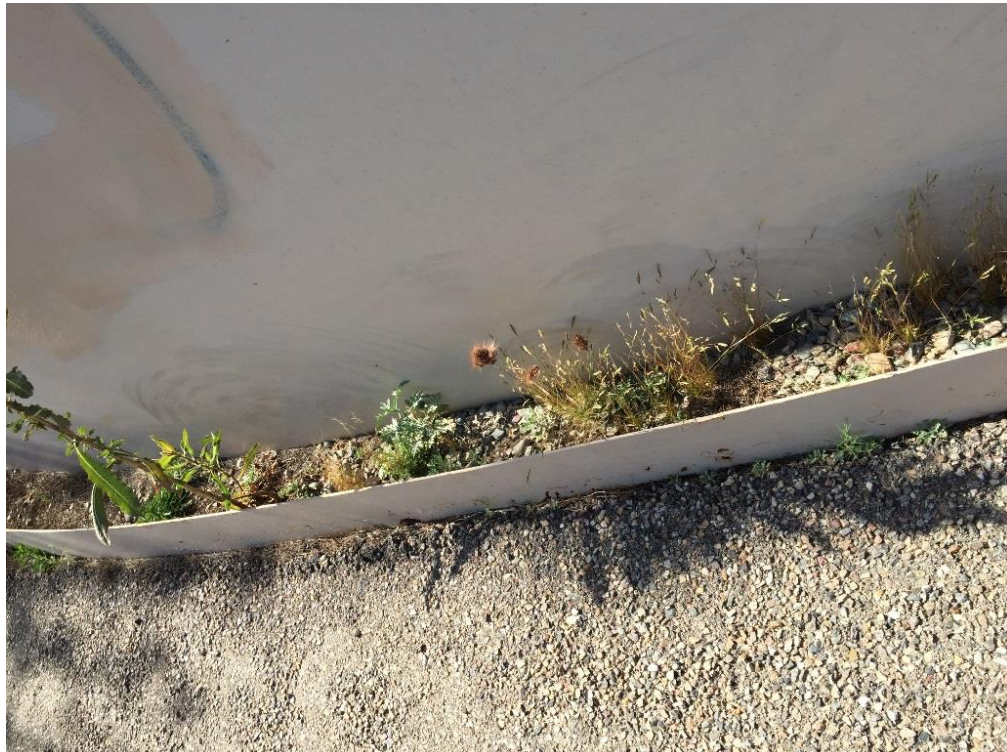
Summary: The foundation is present and there appears to be no discrepancies. Foundation ring is intact and in good condition.

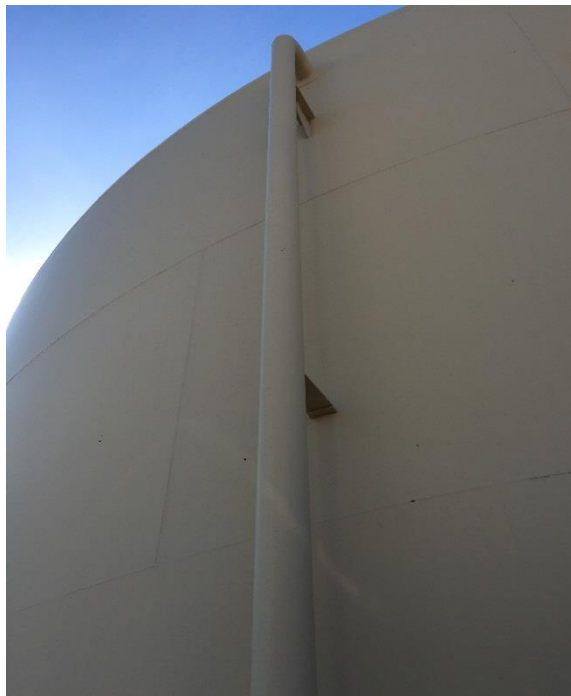
Summary: The overflow has good coating conditions overall. There were no discrepancies noted at the time of inspection.

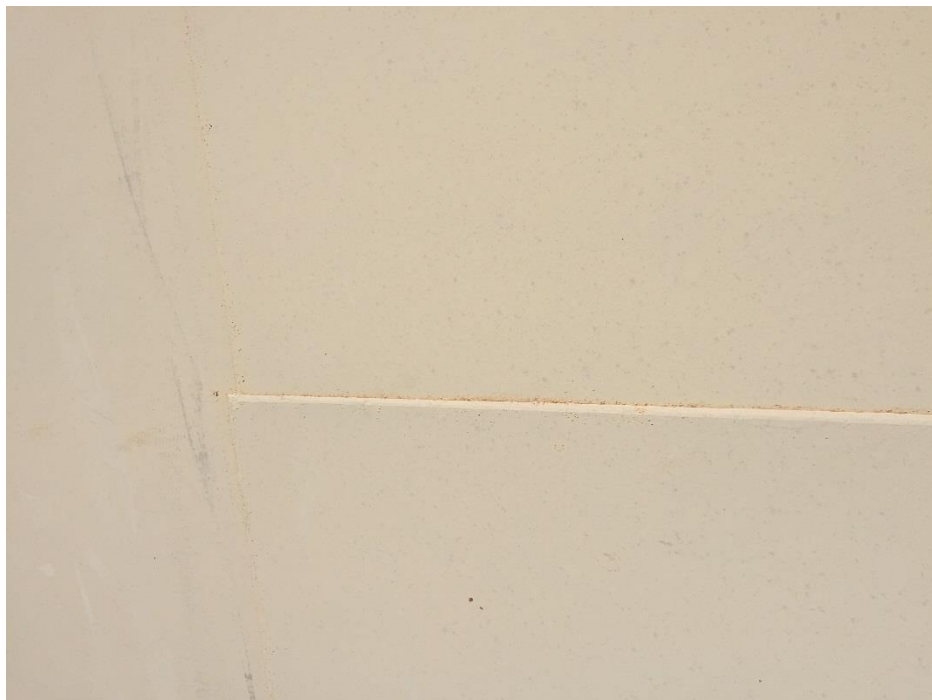
Summary: The roof panels have good coating conditions overall. Heavy chalking present to coating.

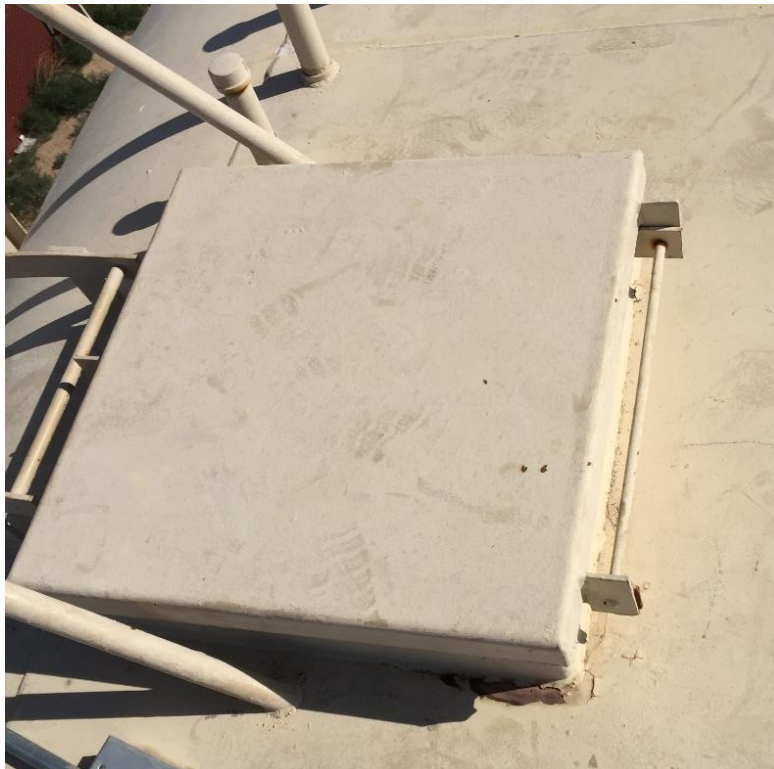
Summary: The hatch has good coating conditions overall. Minor de-lamination and uniform surface corrosion present.

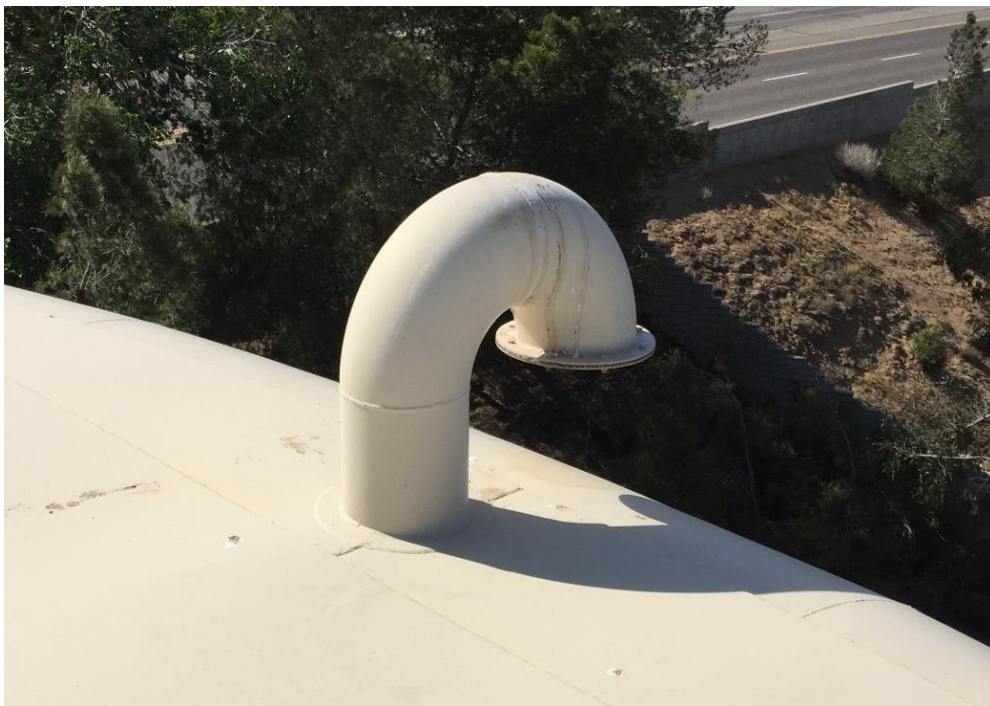
Summary: There are two vents on the tank, and both of them have good coating conditions overall. Screen is not 24 mesh in size and should be replaced to meet AWWA code.

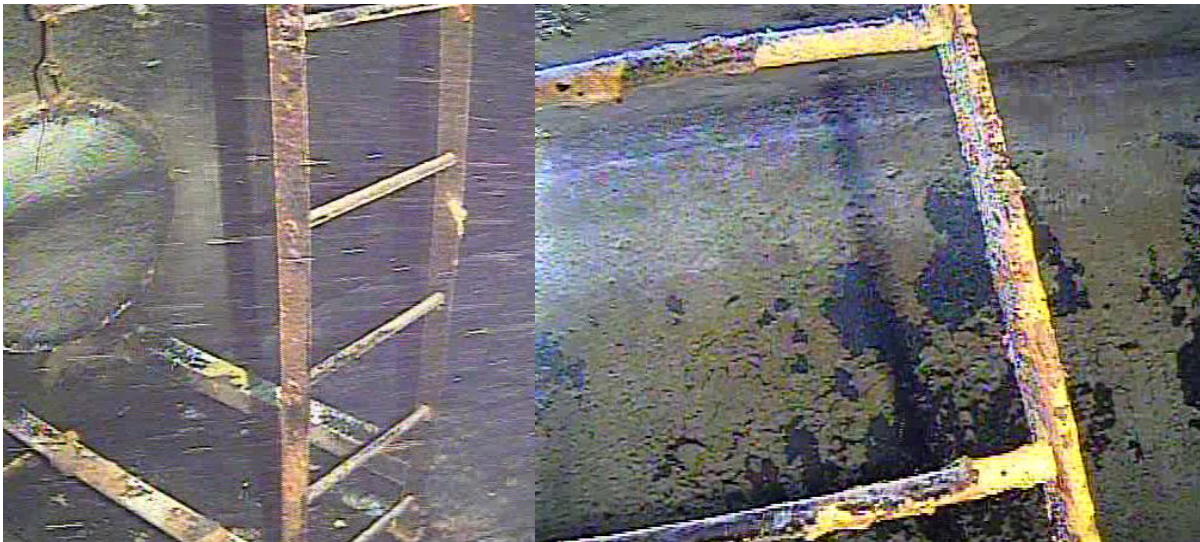
Summary: The ladder has fair coating conditions overall. Moderate uniform surface corrosion present with the majority being towards the top of the ladder.

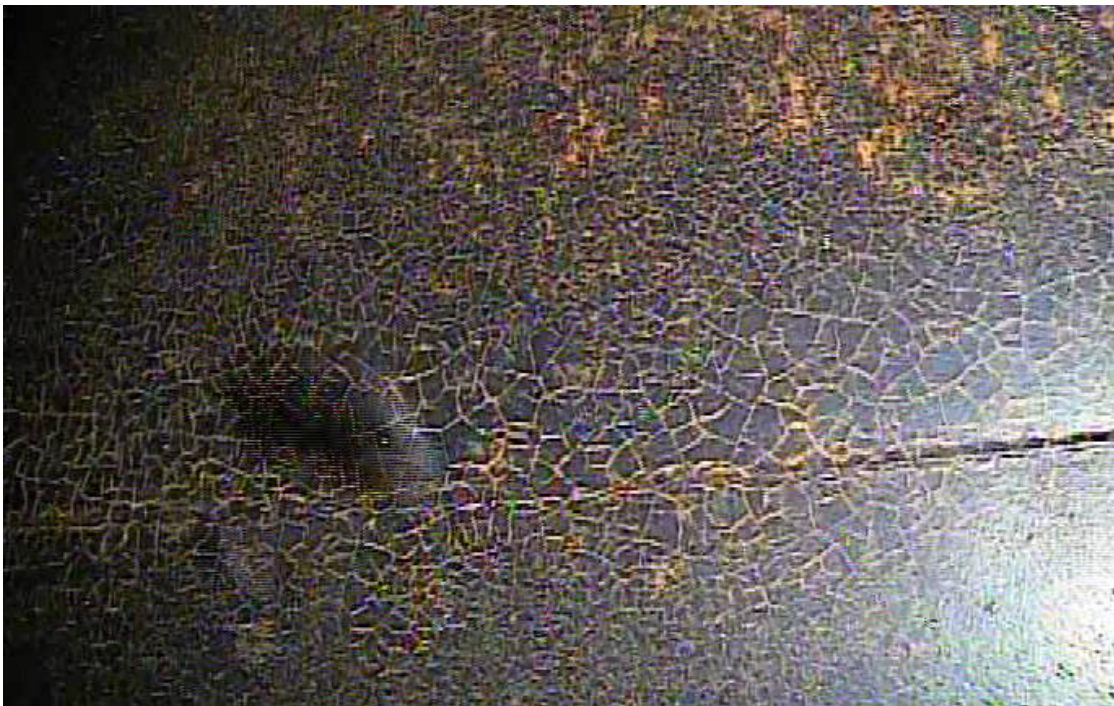
Summary: The wall panels have poor coating conditions overall. There appears to be a large amount of cracking of the coating $\frac{3}{4}$ of the way up the wall panels. Heaviest amount of cracking to the coating and corrosion on the panels is at the 12:00- 4:00 positions around the 2nd weld seam.

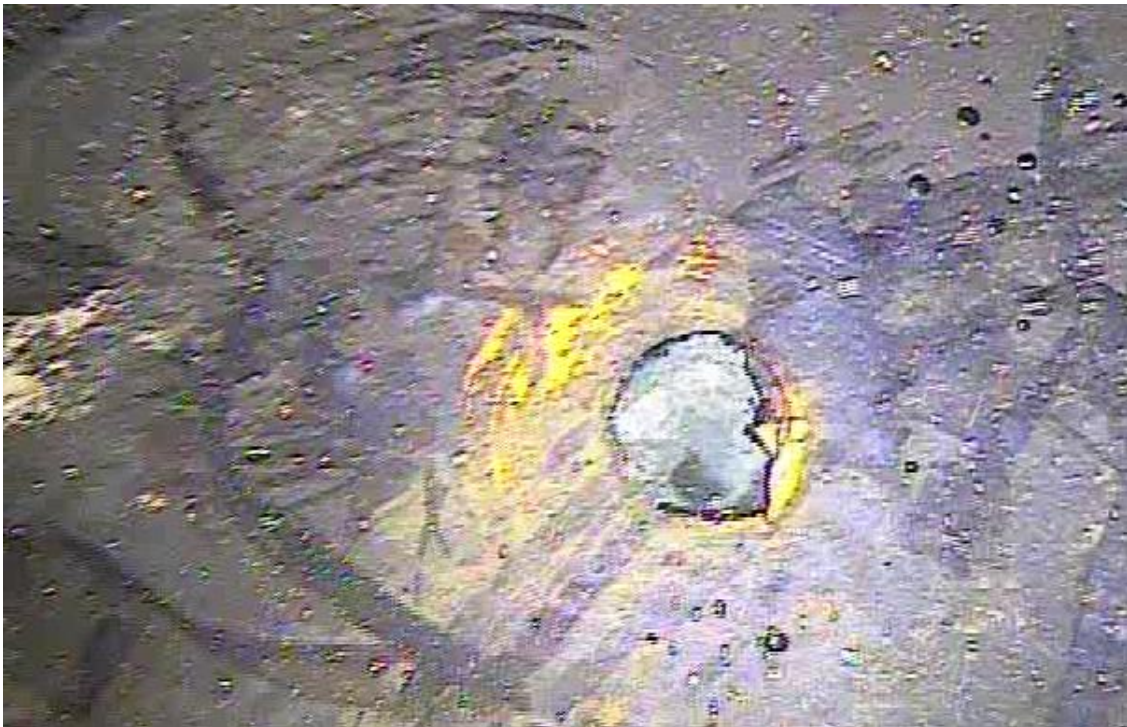
Summary: The floor panels have fair to good coating conditions overall. Corrosion nodules appear on the floor to wall seam with up to 1/8" deep pitting. Minor uniform surface corrosion present mainly in quadrant #4. Some cracking and staining also visible.

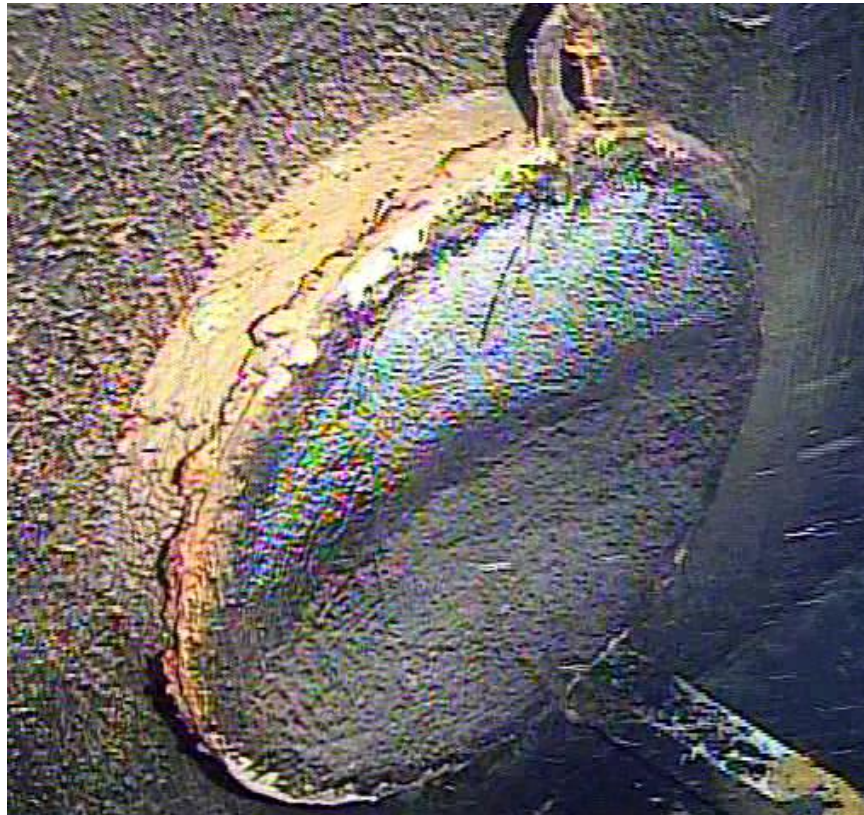
Summary: The manway has fair coating conditions overall. Minor uniform surface corrosion and corrosion nodules noted around the seam and chain.

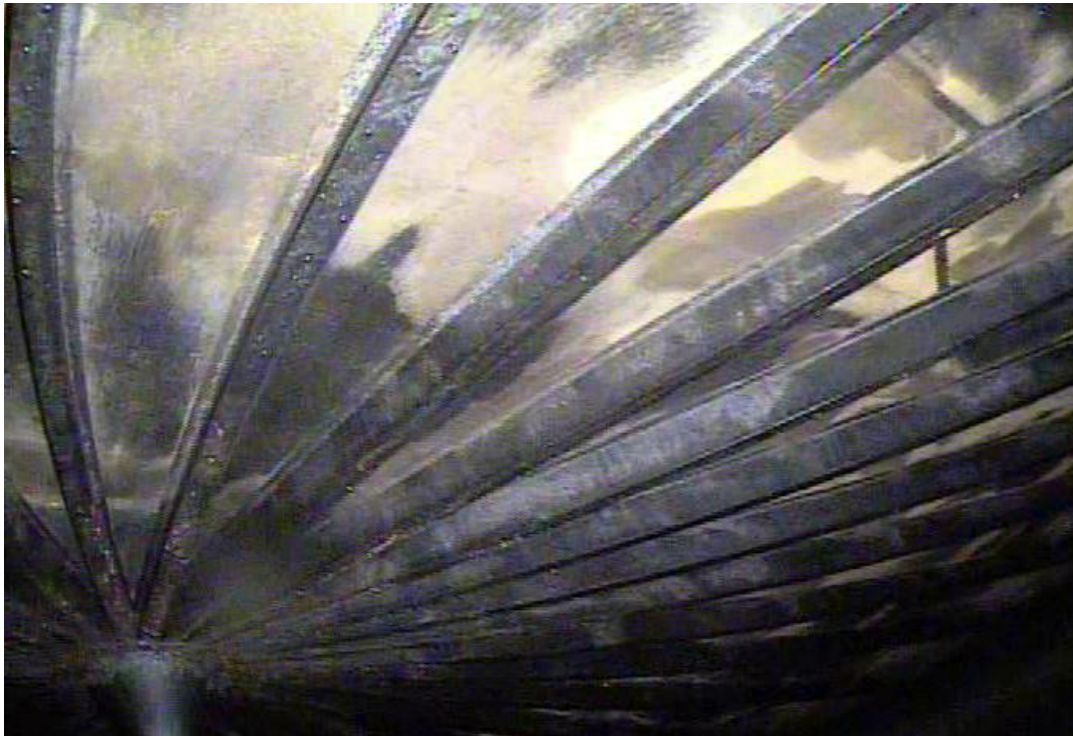
Summary: The roof panels have fair coating conditions overall. Heavy uniform surface corrosion present to the roof panels. Condensation noted on the flange of the I-Beams. The roof hardware is also in fair condition.

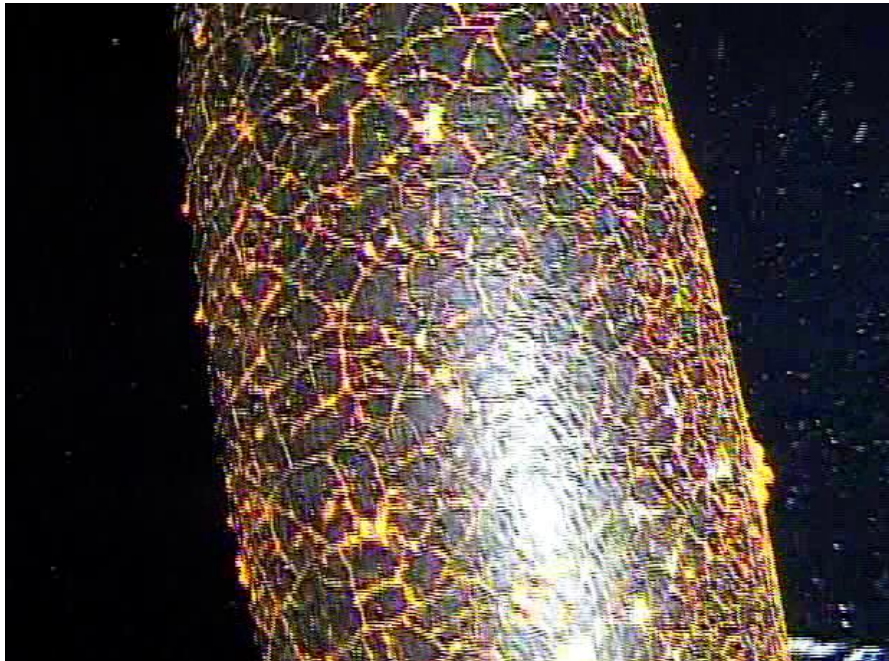
Summary: The support columns have poor coating conditions overall. Cracking in the coating present similar to the wall panels. Uniform surface corrosion and corrosion nodules are present where the coating has failed.

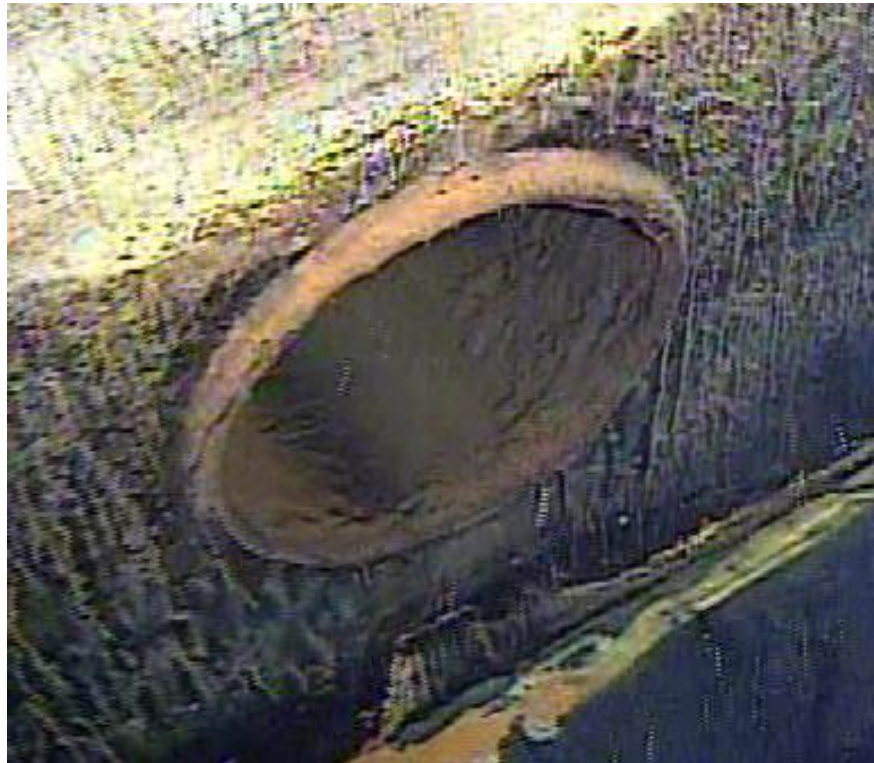
Summary: The inlet/outlet has good coating conditions overall. No major discrepancies noted during the inspection.

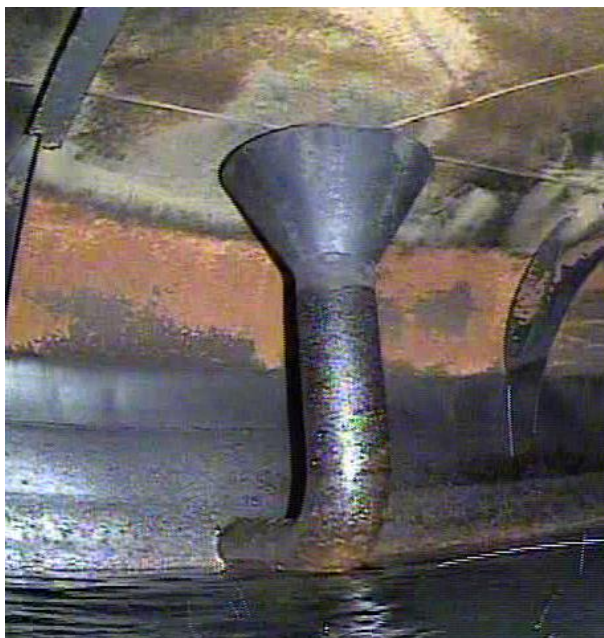
Summary: The overflow has fair coating conditions overall. Significant uniform surface corrosion noted.

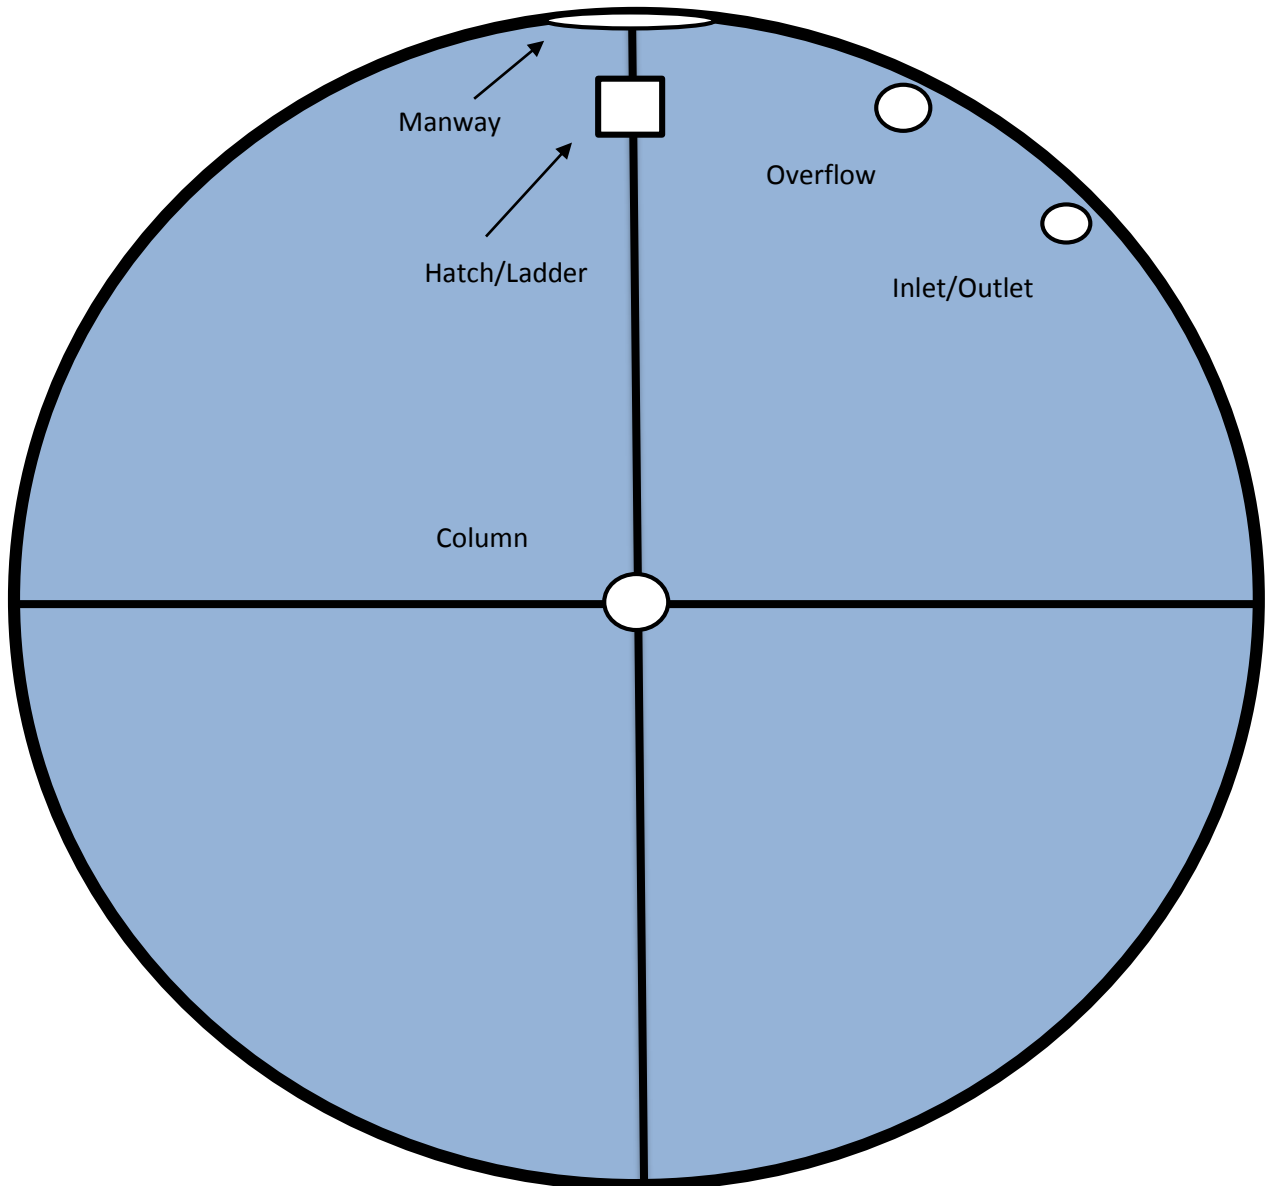
Spring Valley Lake, CA
32' High x 80' Diameter, 1MG
Steel Welded On-grade
