21670 E Geddes Place  
Centennial, CO 80016  
Office Phone: 800-637-1322  
Office Fax: 303-309-0097

**Inspection Report for San Bernardino County**

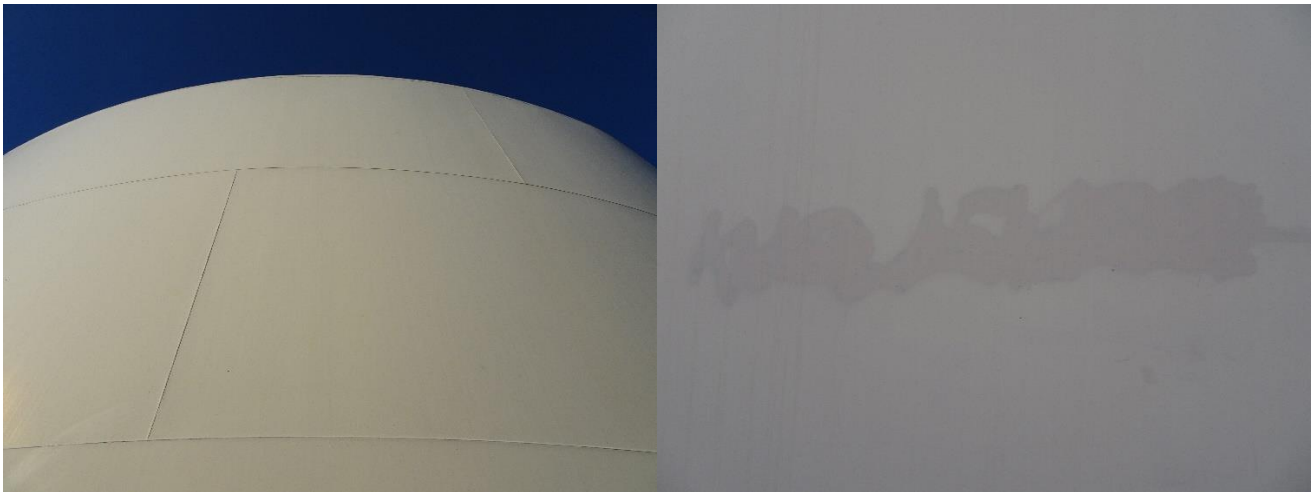
**Summary:** The exterior wall panels have good coating conditions overall. Minor de-lamination of the coating occurring and leading to surface corrosion. Graffiti has been covered.

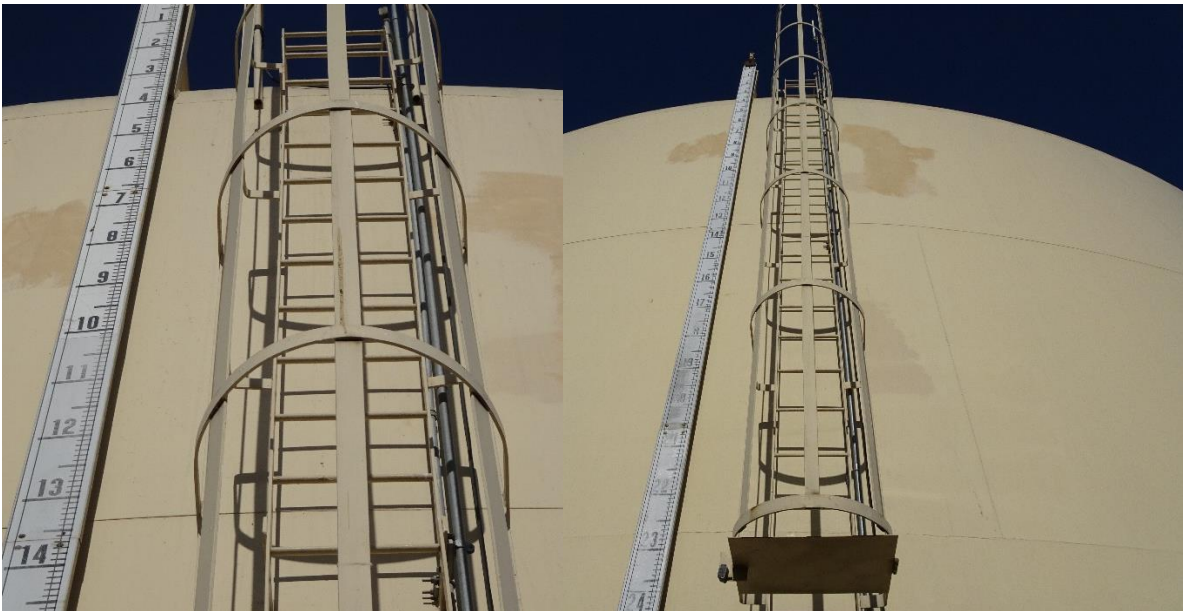
**Summary:** The exterior ladder has good coating conditions overall. Minor de-lamination of the coating occurring on the safety cage door. Surface corrosion noted on the side rails and cage. The ladder rungs are  $\frac{3}{4}$ ". The ladder width is 15" and the distance between the tank and ladder is 7.75".

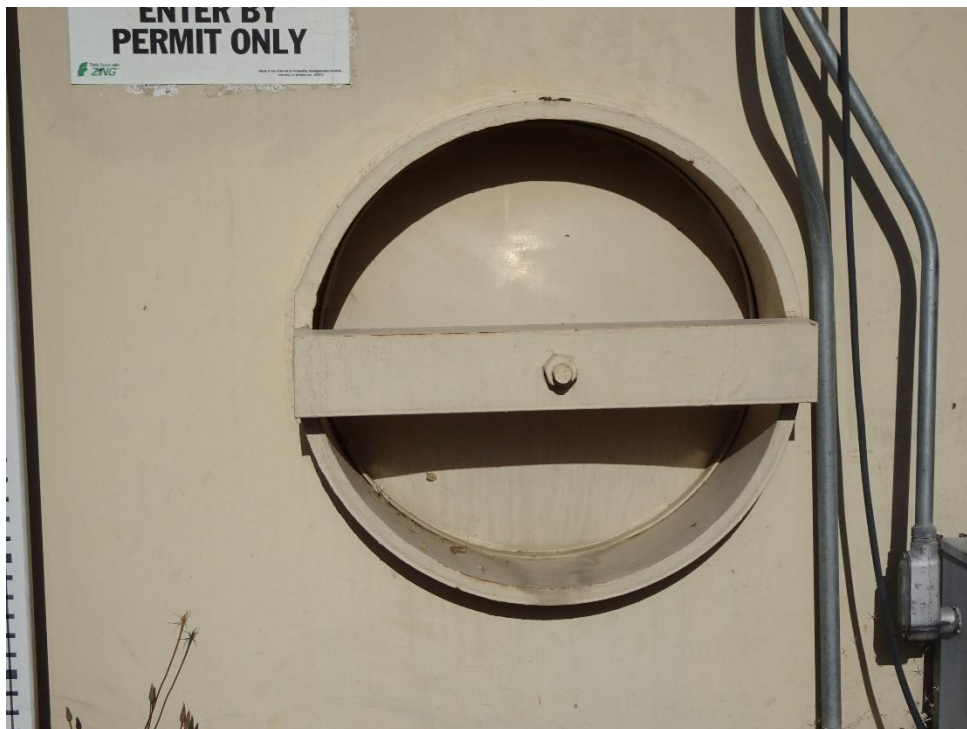
**Summary:** The manway has good coating conditions overall. Minor surface corrosion noted on the back brace and on the outer lip.

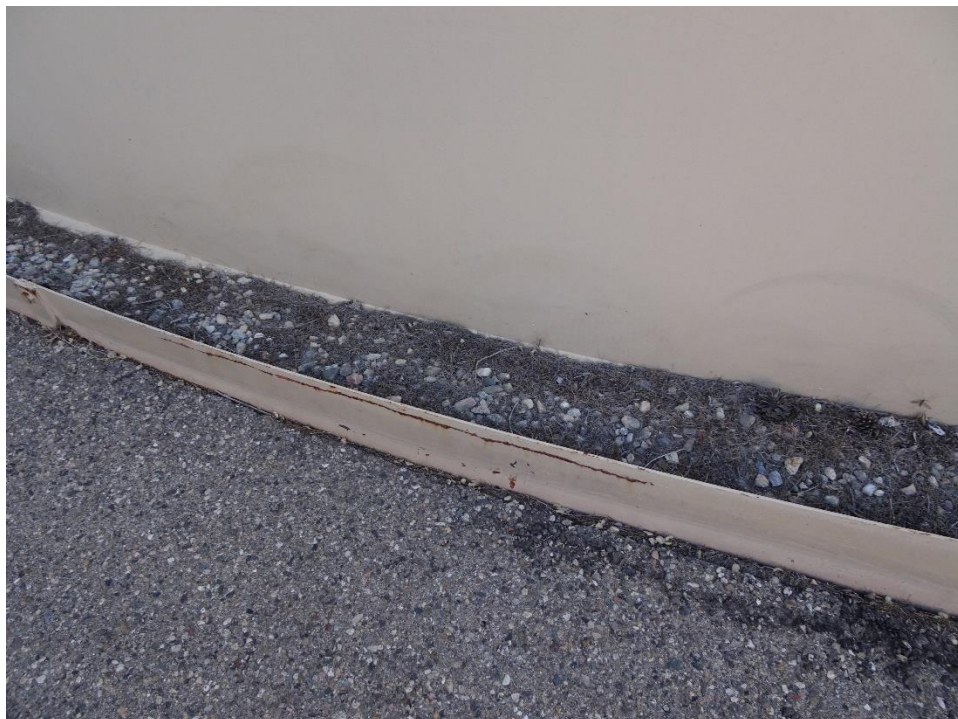
**Summary:** The foundation consists of a metal foundation ring with gravel fill. De-lamination of the coating and surface corrosion noted on the ring.

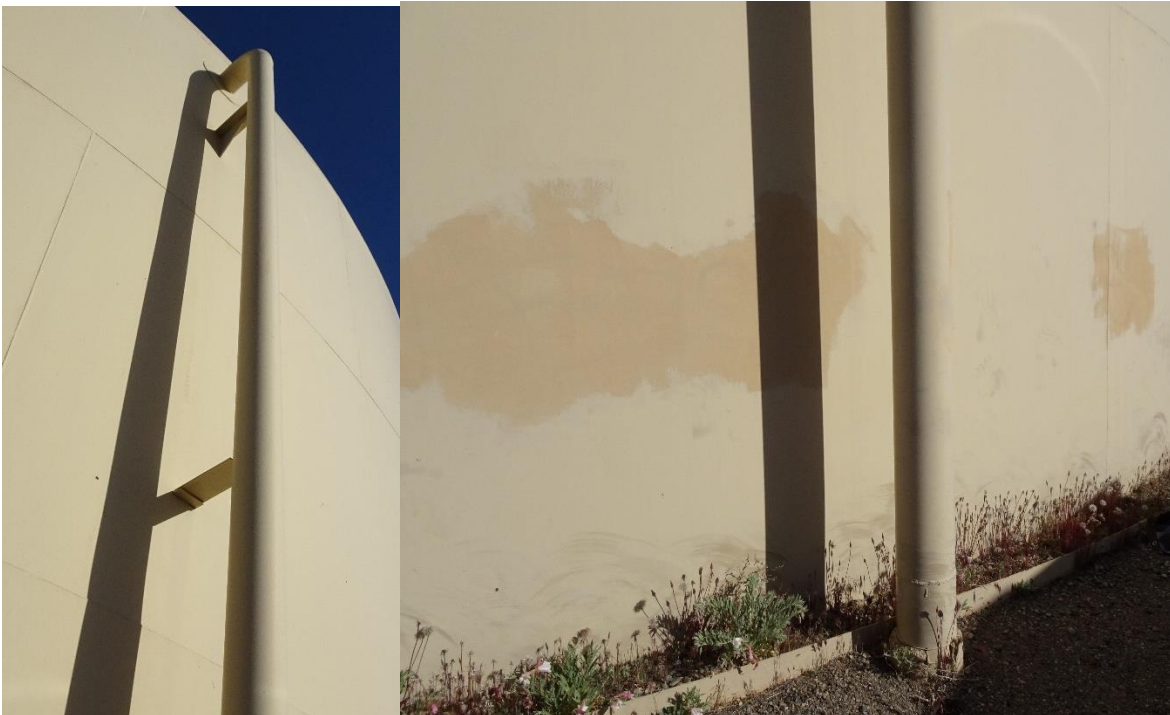
**Summary:** The overflow has good coating conditions overall. Surface corrosion noted on the supports. There is concrete missing from the concrete pad where the overflow pipe terminates.

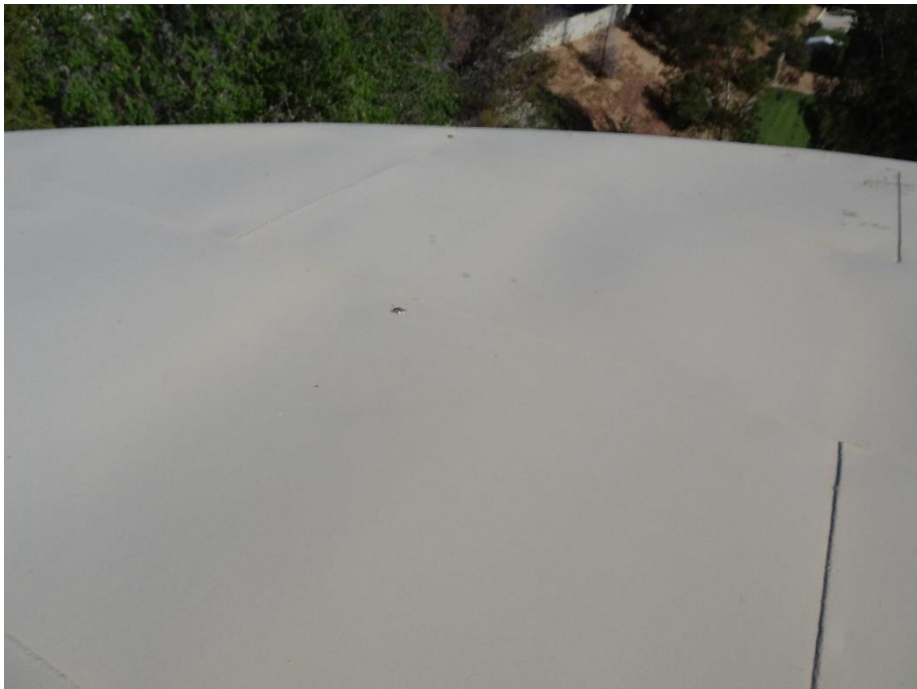
**Summary:** The roof panels have good coating conditions overall. Minor low spot occurring near the 8:00 position. Minor surface corrosion noted on the post at the center of the roof. Minor de-lamination of the coating present on the seams.

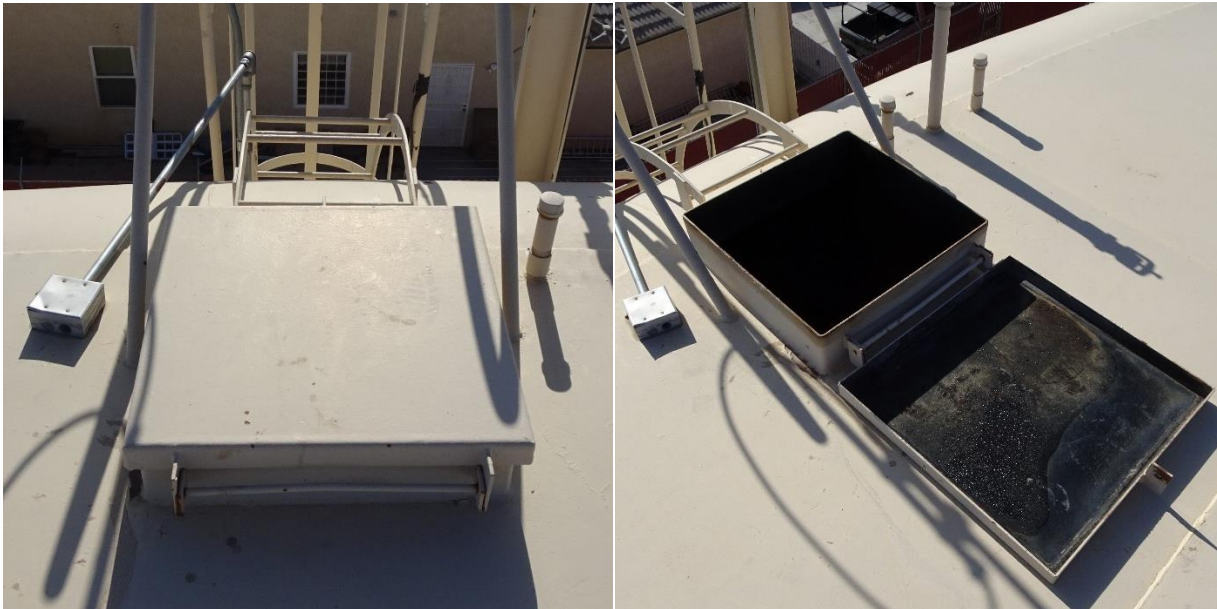
**Summary:** The hatch has good coating conditions overall. De-lamination of the coating noted on the inner walls of the hatch and on inner lid. Surface corrosion present on the hinge hardware. Recommend installing a gasket to create a seal to prevent bugs/insects from entering the tank.

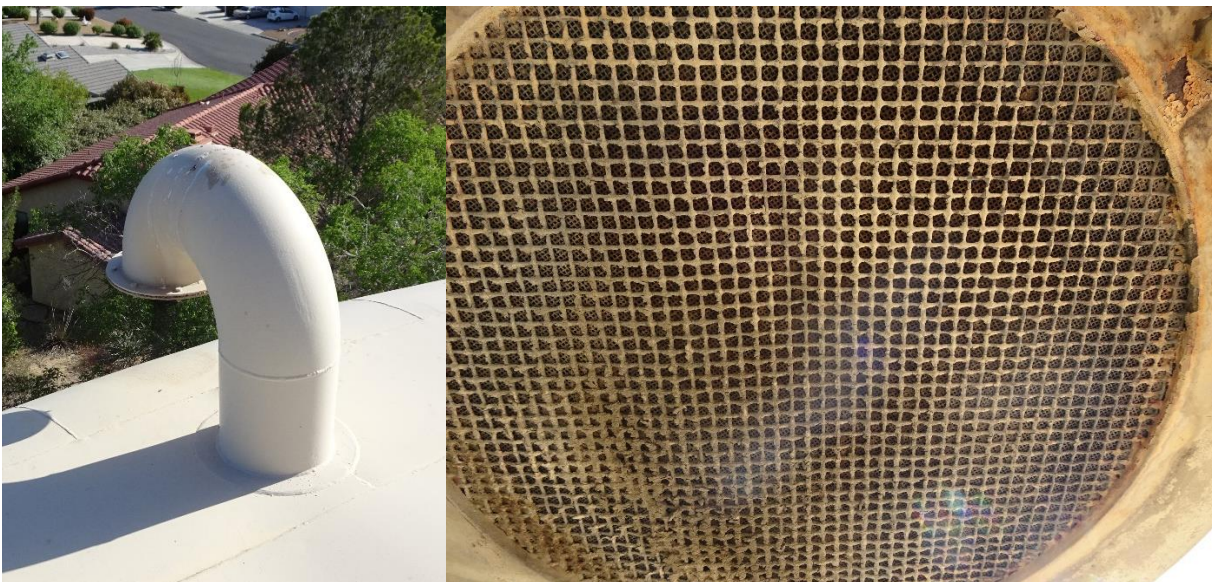
**Summary:** The 2 vents have good coating conditions overall. Surface corrosion noted on the hardware. A fine mesh screen is present and intact.

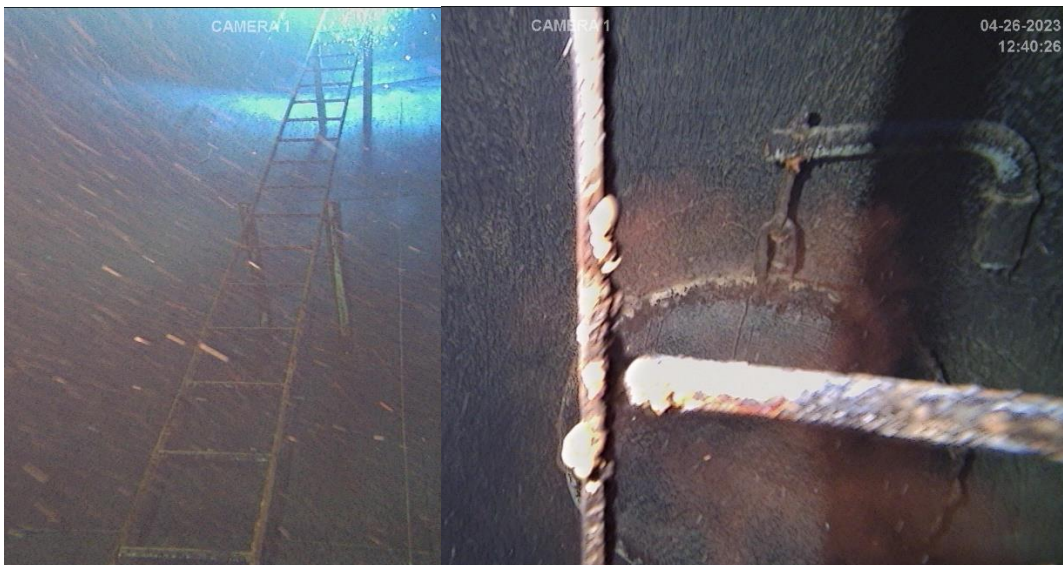
**Summary:** The internal ladder has poor coating conditions overall. The coating is cracking. Surface corrosion and corrosion nodules forming mainly on the siderails and stand offs. Some de-alloying of the metal occurring.

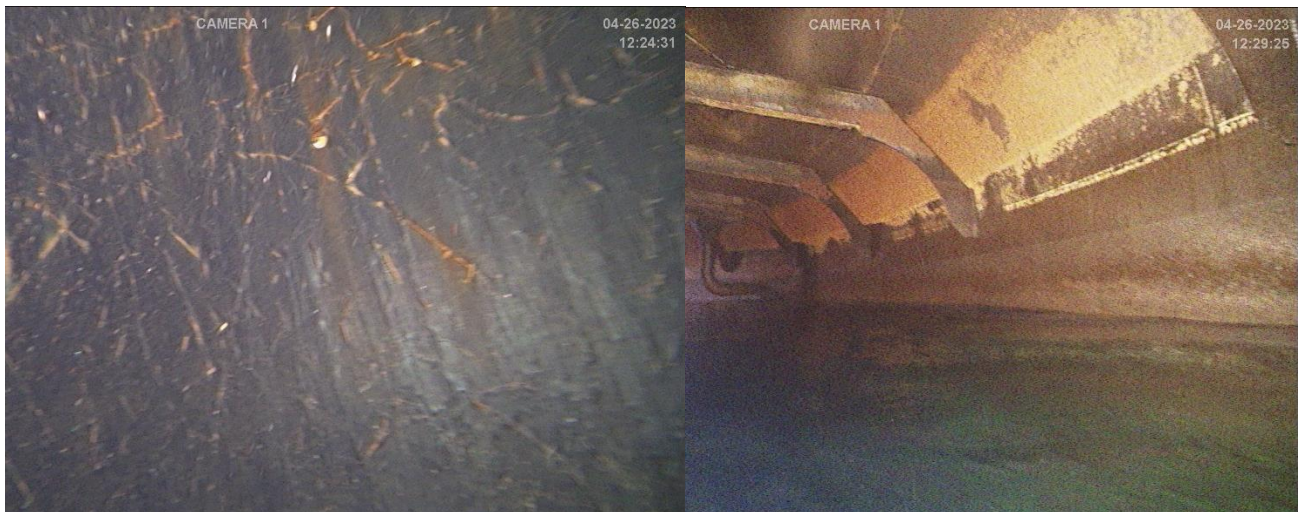
**Summary:** The wall panels have poor coating conditions overall. Cracking of the coating occurring at the waterline and leading to surface corrosion and corrosion nodules. Corrosion nodules also forming at the wall to floor seam.

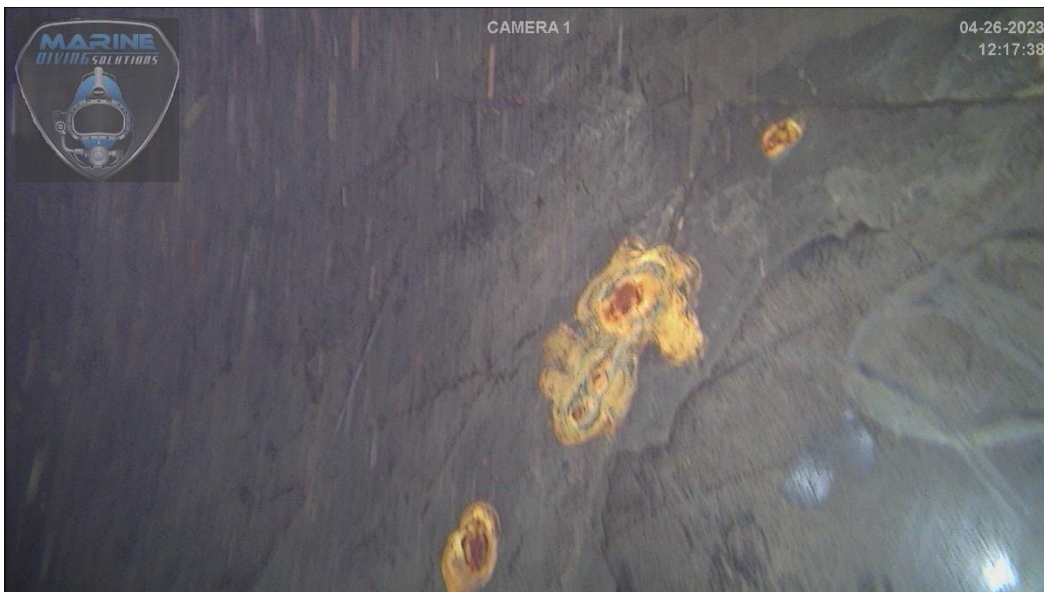
**Summary:** The floor panels have fair coating conditions overall. The floor is uneven. Minor cracking of the coating present. Large corrosion nodules forming with de-alloying and pitting of the metal visible.

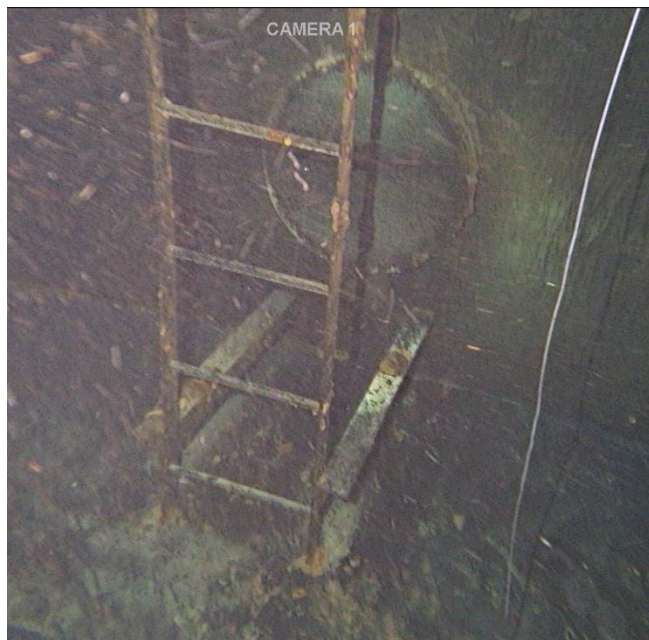
**Summary:** The manway has poor coating conditions overall. Surface corrosion built up on the gasket. Heavy blistering of the coating noted.

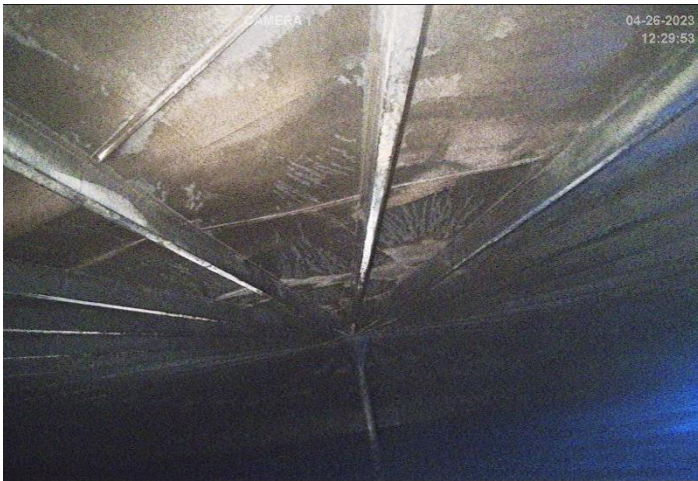
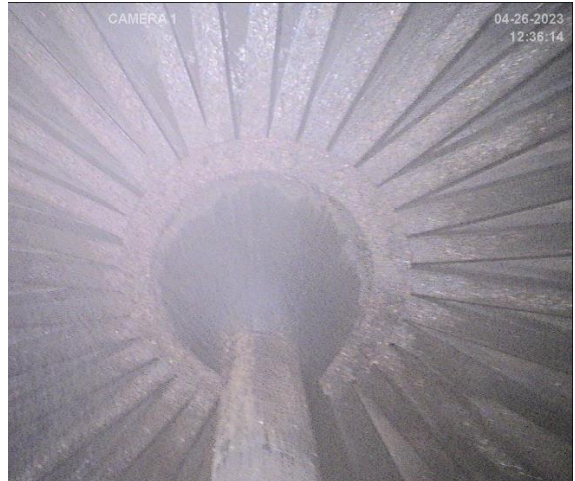
**Summary:** The roof panels have fair to poor coating conditions overall. Surface corrosion noted on the supports, panels and at the roof to wall seam. Condensation built up around the center of the tank. The coating appears to be thin on the roof panels.

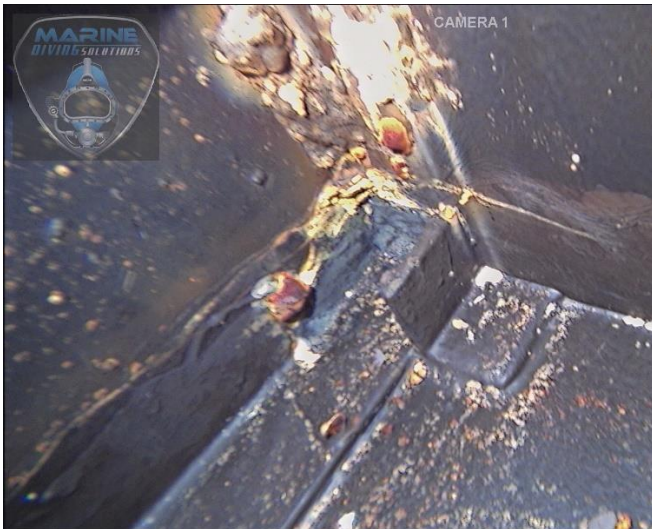
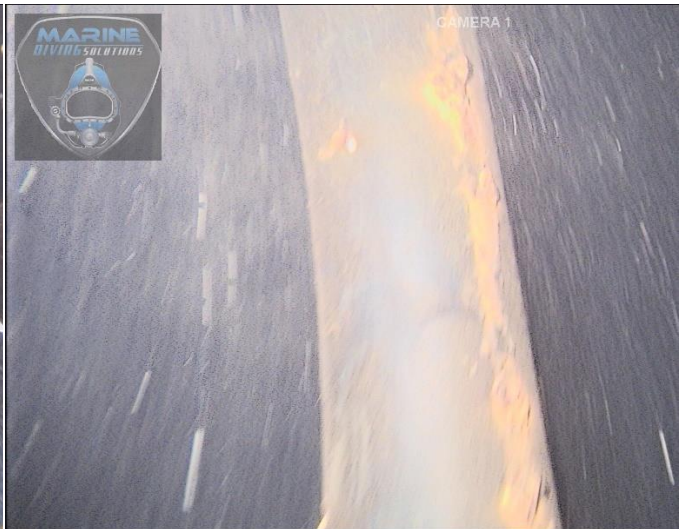
**Summary:** The support column has poor coating conditions overall. The coating is cracking. Blistering of the coating and corrosion nodules present around the base and on the column. De-alloying noted on the base seams.

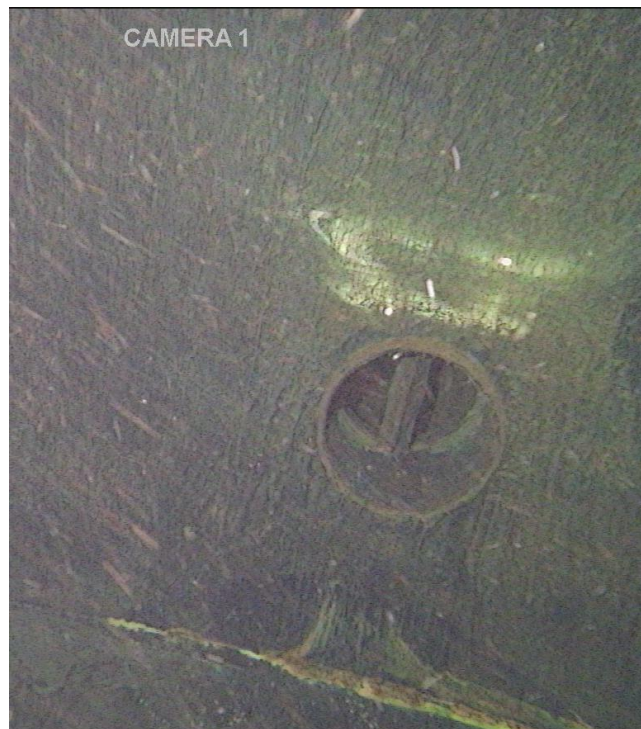
**Summary:** The inlet has fair coating conditions overall. Surface corrosion and corrosion nodules forming. Cracking of the coating occurring on the interior.

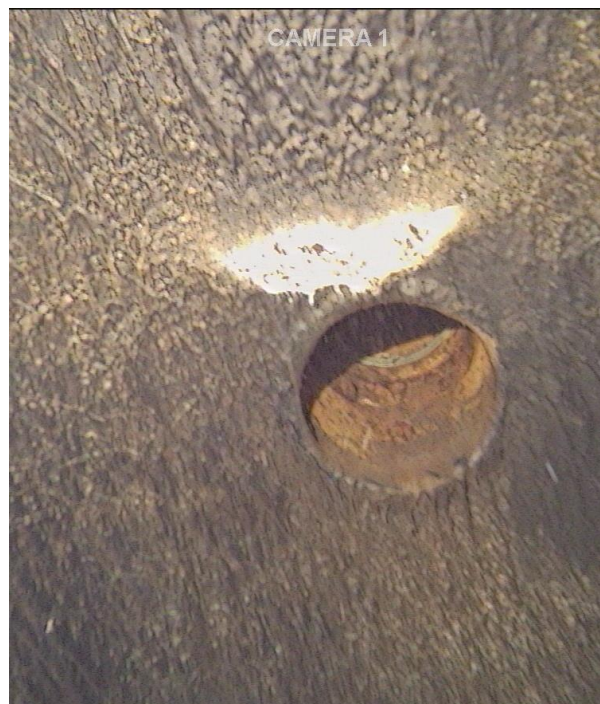
**Summary:** The outlet has good to fair coating conditions overall. Heavy staining occurring. Surface corrosion present on the bottom of the pipe.

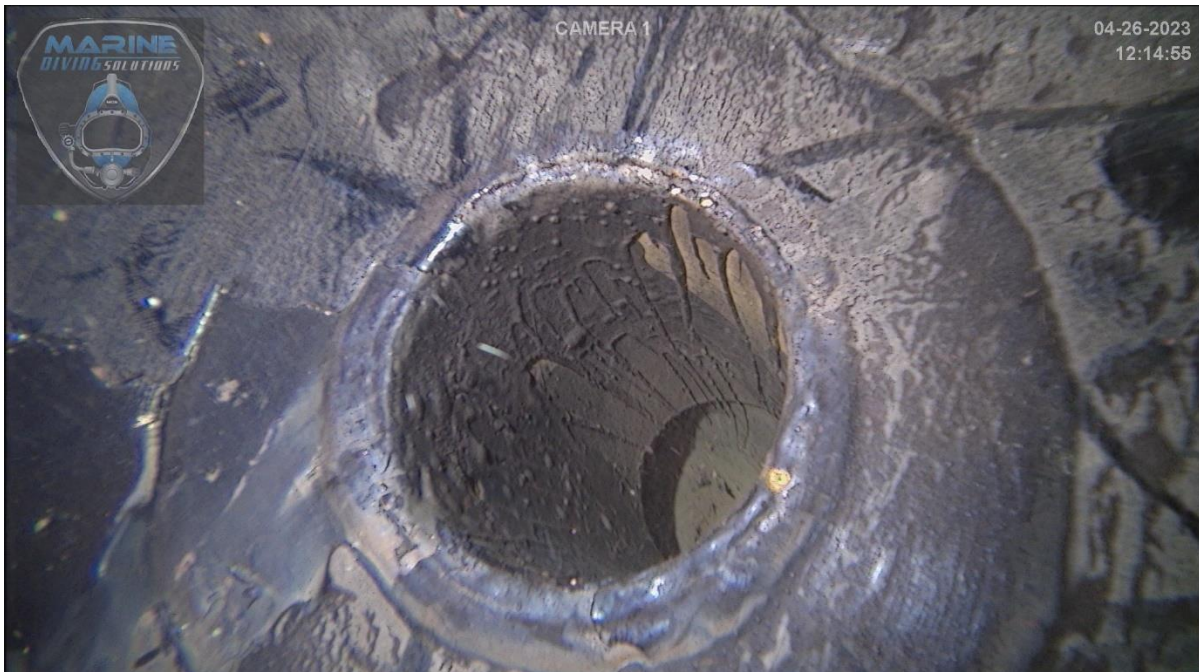
**Summary:** The drain has good coating conditions overall. Surface corrosion noted along the weld seam and outer lip. Some blistering of the coating present.

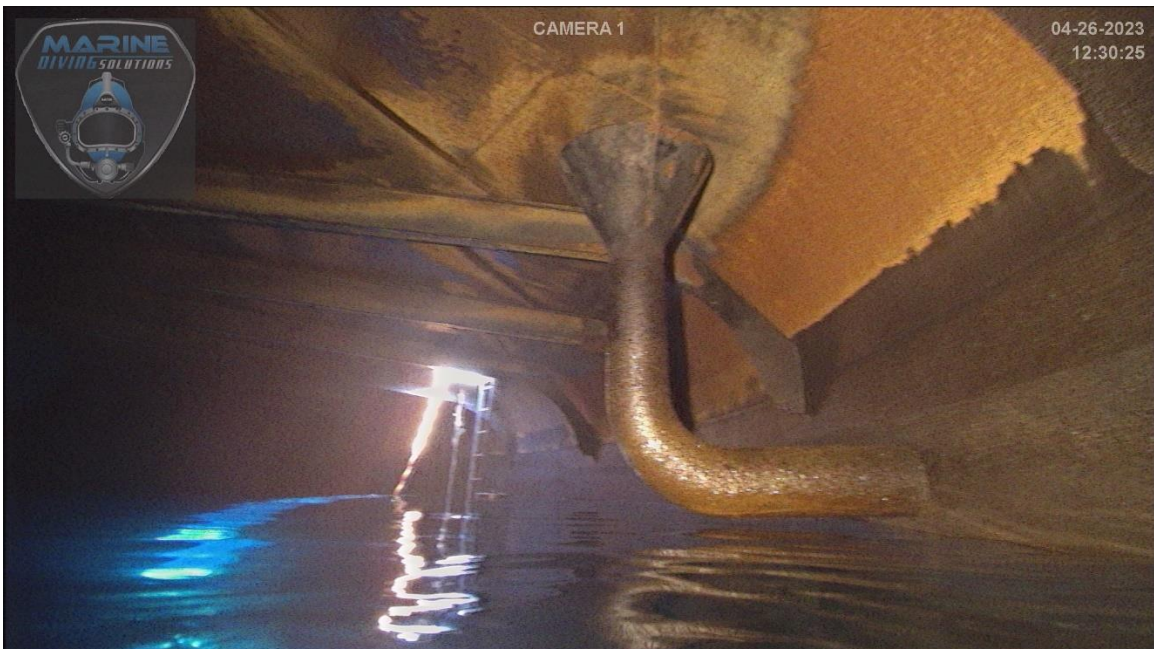
**Summary:** The overflow has fair coating conditions overall. Surface corrosion noted on the drain funnel. Some cracking of the coating visible.

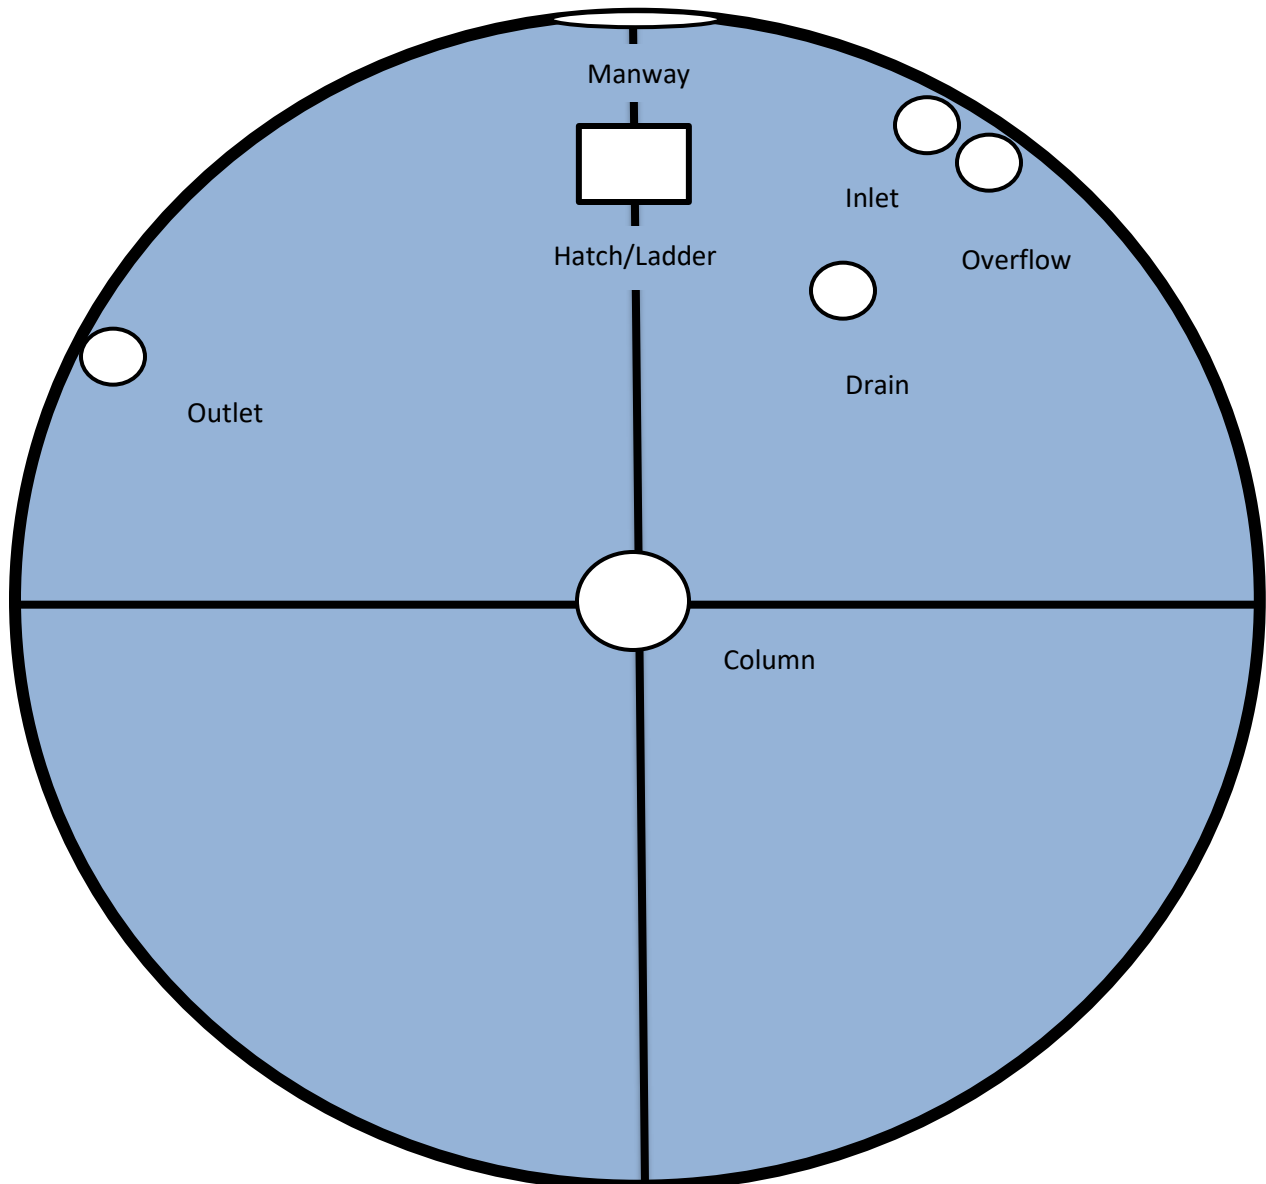
Steel Welded On-grade- 1MG Pebble Beach Tank
